#### **Town of Ramapo**

# Comprehensive Plan Amendment for the Northeast Ramapo Development Plan and Comprehensive Plan Update of Town-wide Existing Conditions and

# DRAFT GENERIC ENVIRONMENTAL IMPACT STATEMENT (DGEIS) APPENDICES – VOLUME IV OF IV:

# APPENDIX L: MINISCEONGO PARK SITE PLAN INFORMATION

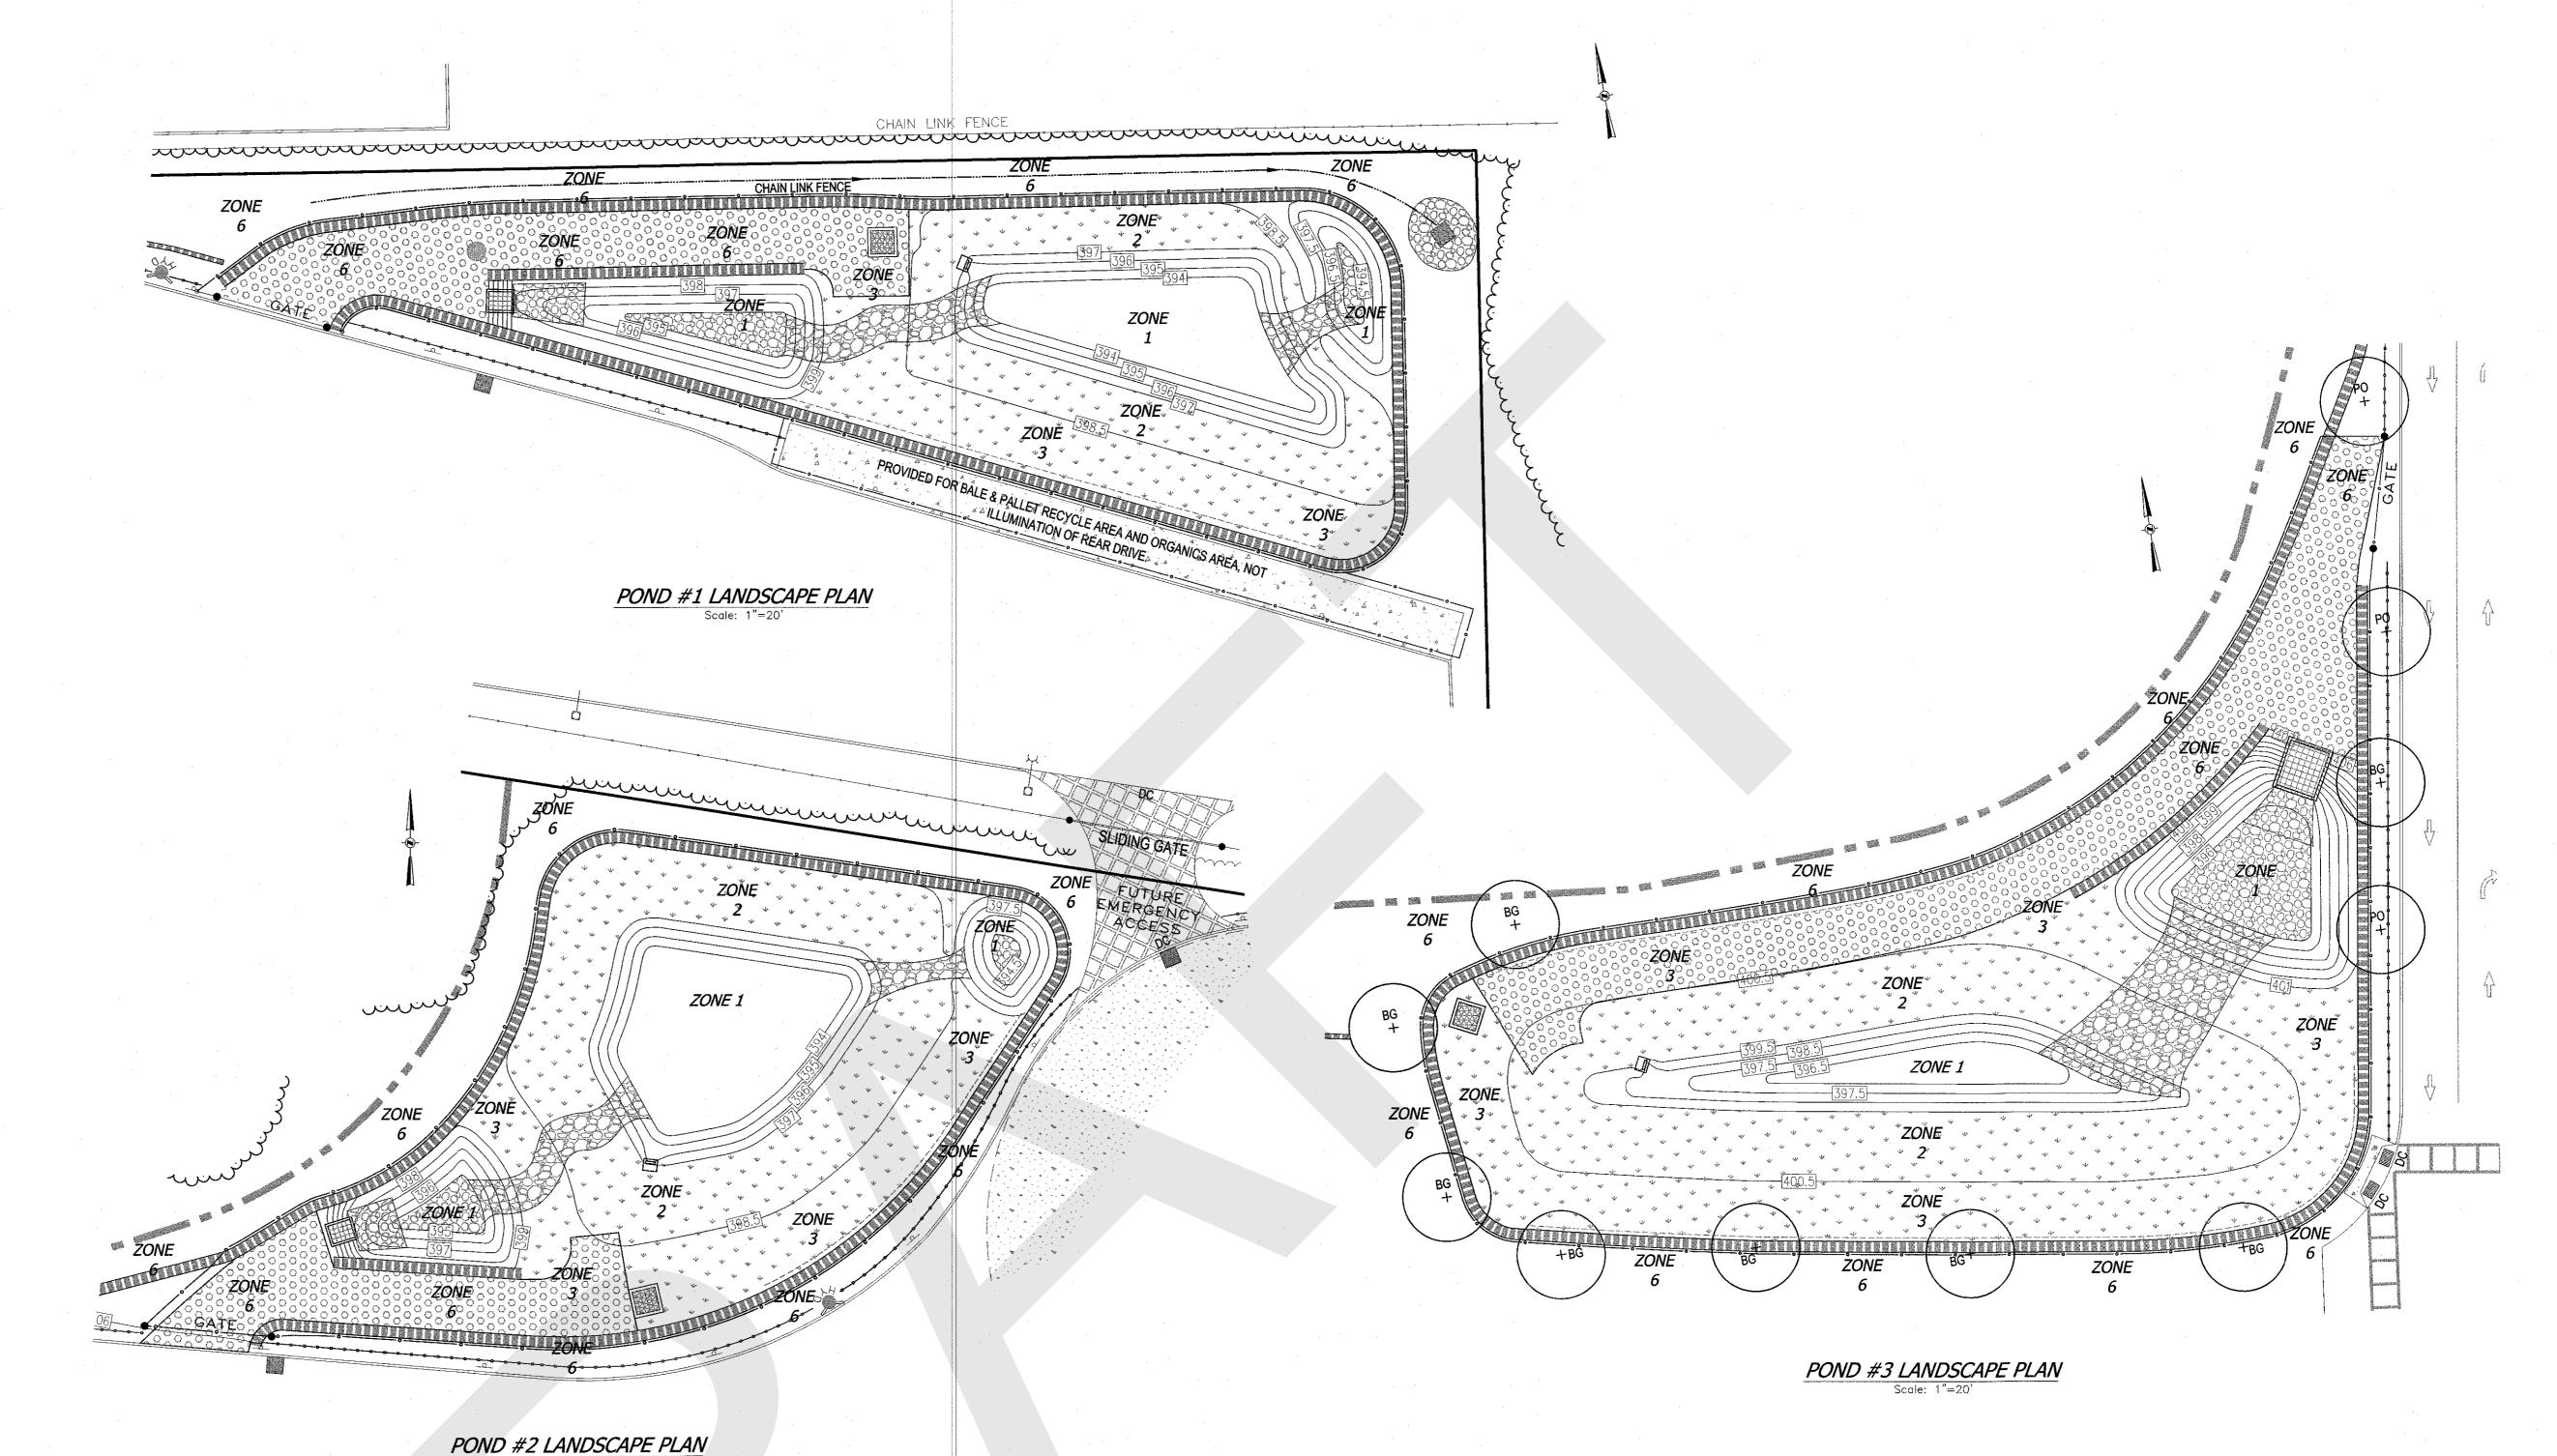
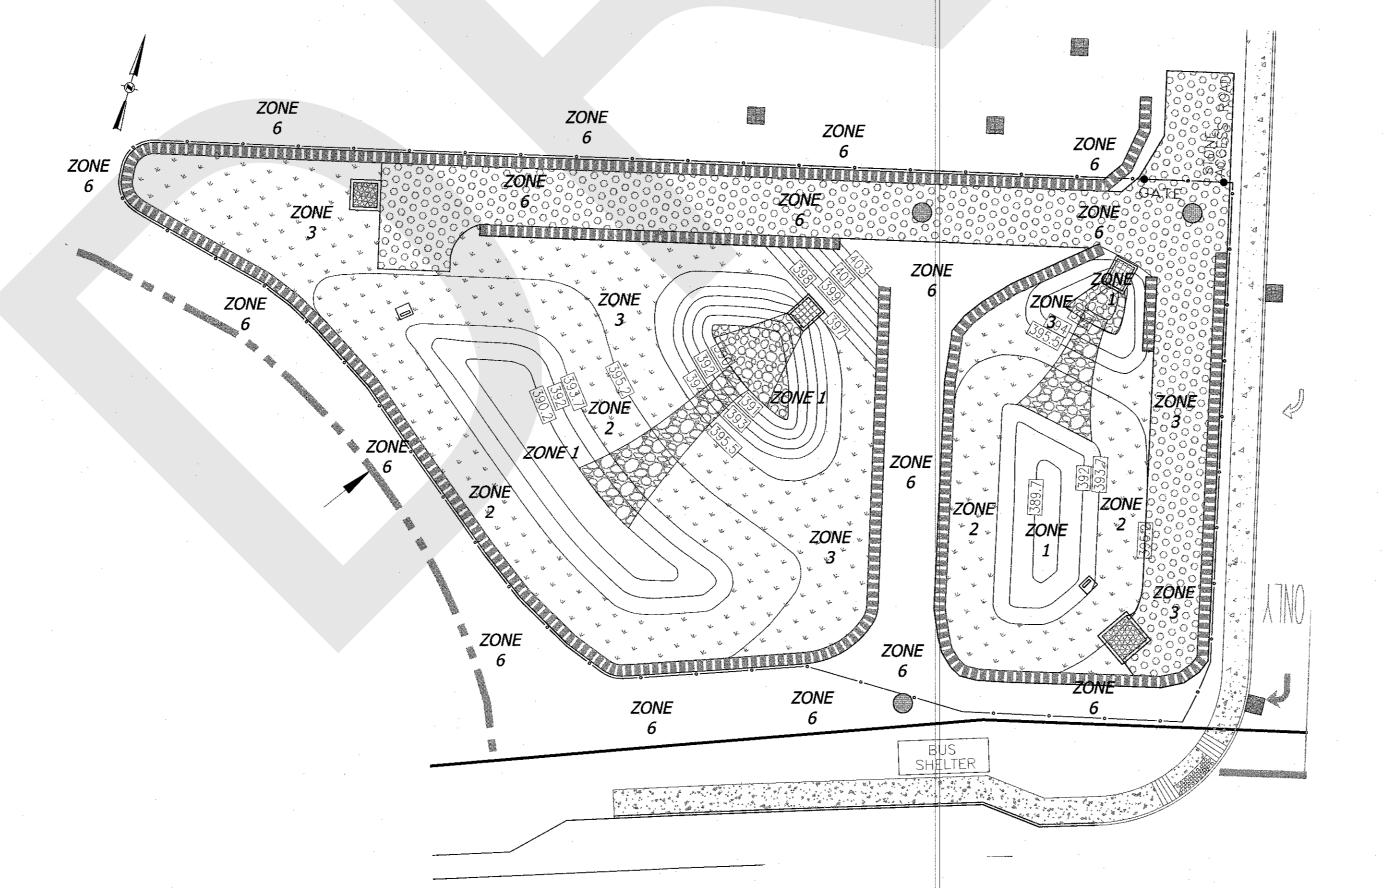
POND #4 LANDSCAPE PLAN

#### Hydrologic Zones Description and Hydrologic Conditions per NYSDEC SWMDM

Zone 2 includes all areas that are inundated below the normal pool to a depth of one foot, and is the primary area where emergent plants will grow in a stormwater wetlands. Zone 2 also coincides with the aguatic bench found in stormwater ponds. This zone offers ideal conditions for the growth of many emergent wetland species. These areas may be located at the edge of the pond or on low mounds of earth located below the surface of the water within the pond. When planted, Zone 2 can be an important habitat for many aquatic and nonaquatic animals, creating a diverse food chain. This food chain includes predators, allowing a natural regulation of mosquito populations, thereby reducing the need for insecticidal

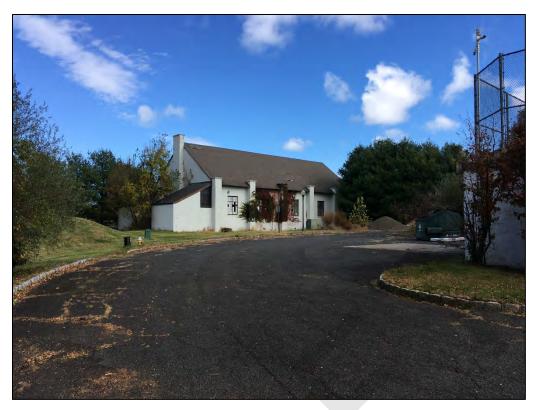
Photograph 1. Building 12 (1991), looking NE at the south facade (Field Photograph Bldg12\_2019\_IMG-0680, 10/18/19).

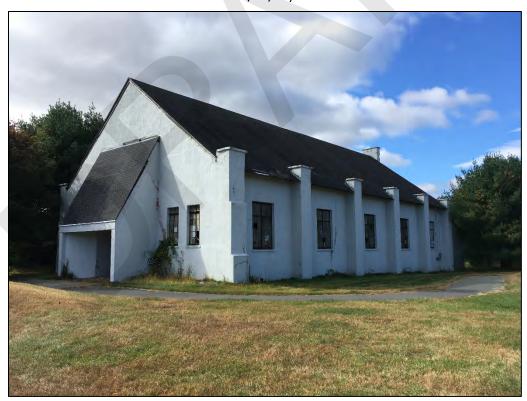
Photograph 2. Building 12 (1991), looking SW at the north (right) and east facades (Field Photograph Bldg12\_2019\_IMG\_0681, 10/18/19).

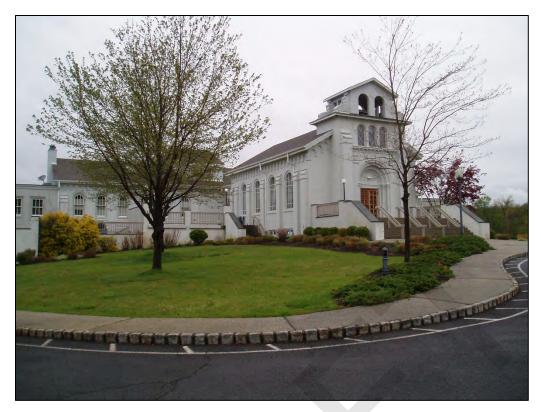
Photograph 3. Bldg. 11 (1991), the golf course clubhouse; originally, the administration bldg. and school. Looking NE at the south entrance and west wing (Field Photograph Bldg11\_20160504\_P1010035, 5/4/16).

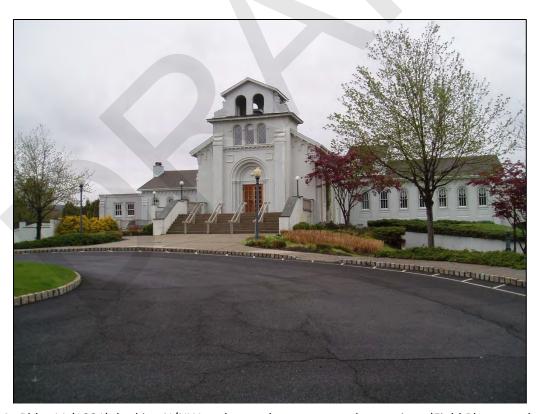
Photograph 4. Bldg. 11 (1991), looking N/NW at the south entrance and east wing. (Field Photograph  $Bldg11_20160504_P1010036, 5/4/16$ )

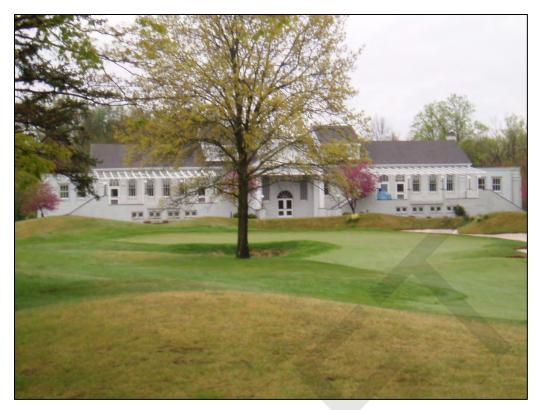
Photograph 5. Bldg. 11 (1991), looking south at the north façade (Field Photograph Bldg11\_20160504\_P1010028, 5/4/16).

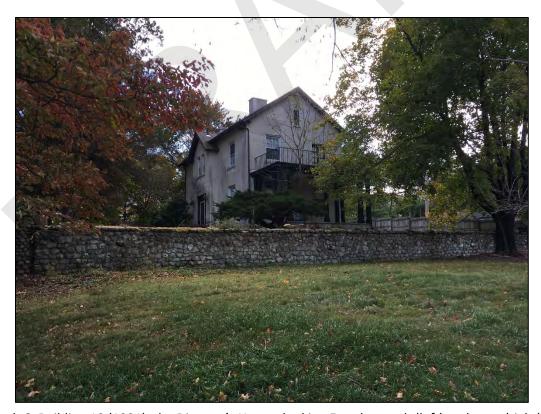
Photograph 6. Building 10 (1991), the Director's House, looking E at the north (left) and west (right) facades. Stone retaining wall W2 across picture front (Field Photograph Bldg10 2019 IMG 0657, 10/18/19).

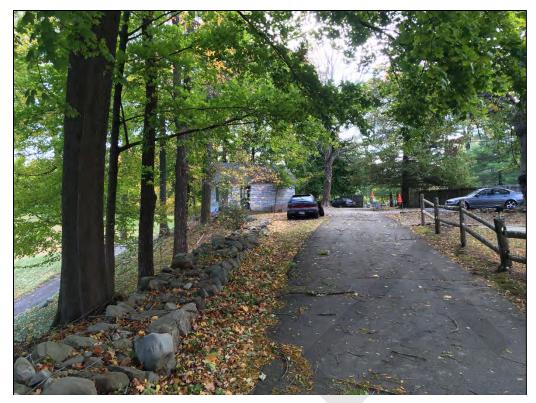
Photograph 7. Building 10 (1991), looking E at the house drive with the unnumbered outbuilding to picture rear and stone retaining wall W3 to left. (Field Photograph Bldg10 2019 IMG 0661, 10/18/19)

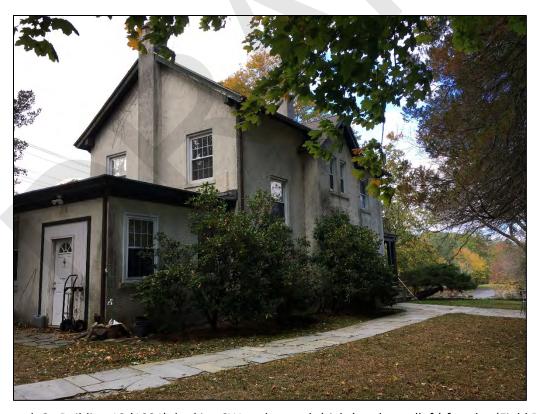
Photograph 8. Building 10 (1991), looking SW at the north (right) and east (left) facades (Field Photograph Bldg10 2019 IMG 0668, 10/18/19)

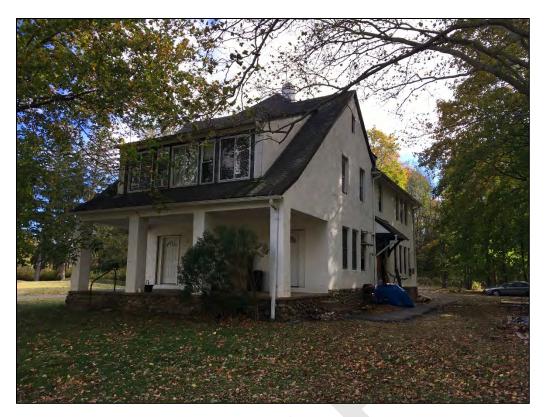
Photograph 9. Building 9 (1991), Ford Cottage, looking E/NE at the west (left) and south (right) facades (Field Photograph Bldg09\_2019\_IMG\_0640, 10/18/19).

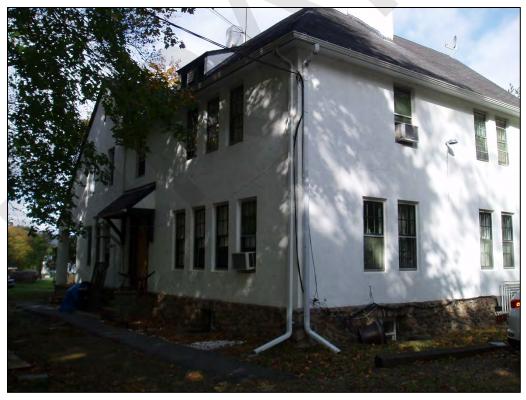
Photograph 10. Building 9 (1991), looking NW at the south (left) and east (right) facades (Field Photograph  $Bldg09_2019_P1010055, 10/18/19$ ).

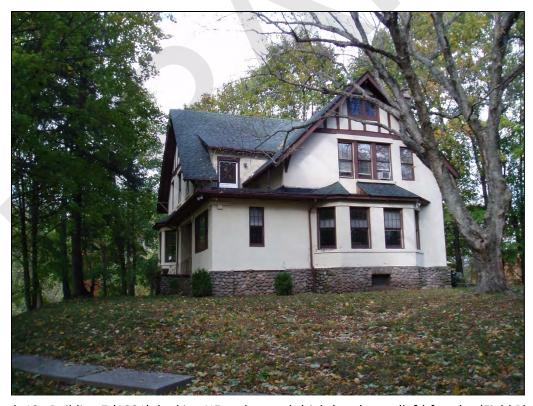
Photograph 12. Building 7 (1991), looking NE at the south (right) and west (left) facades (Field Photograph Bldg07\_2019\_P1010050, 10/18/19).

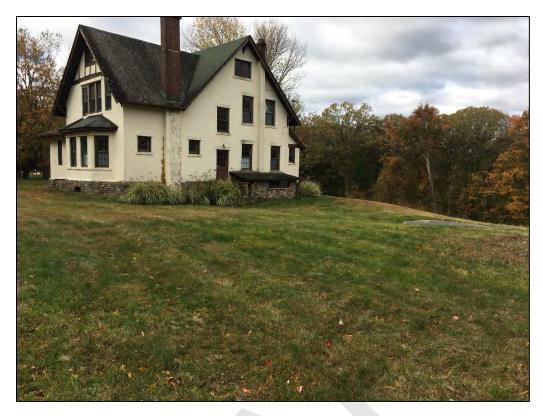
Photograph 13. Building 6 (1991), James Cottage, looking at the north (right) and east (left) facades (Field Photograph Bldg06\_2019\_IMG\_0629, 10/18/19).

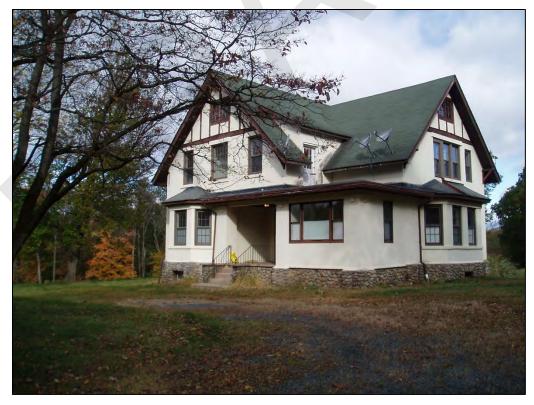
Photograph 14. Building 6 (1991), looking NW at the east (right) and south (left) facades (Field Photograph Bldg06\_2019\_P1010044, 10/18/19).

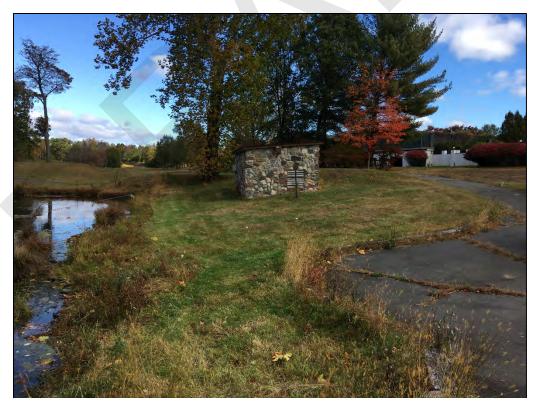
Photograph 16. Building 2019-8, water pump house not noted on Mackey's 1991 figure, looking at the south façade (Bldg2019-08\_PumpHouse\_IMG\_0670, 10/18/19).

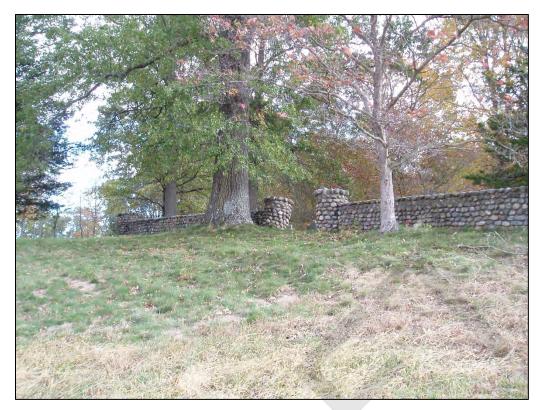
Photograph 17. Cemetery, looking NE at the west facing entry (Field Photograph CemeteryGate\_2019\_P1010031, 10/18/19).

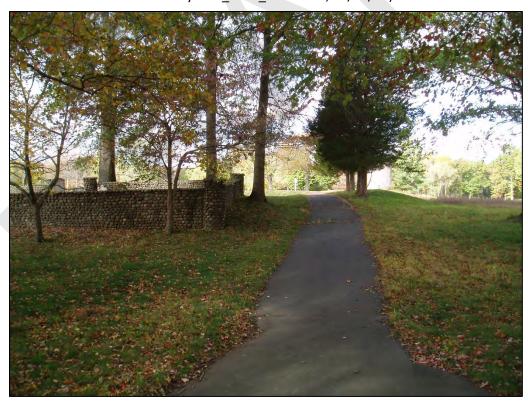
Photograph 18. Cemetery, looking W at the east (left) and north (right) rock walls (Field Photograph CemeteryWall\_2019\_P1010022, 10/18/19).

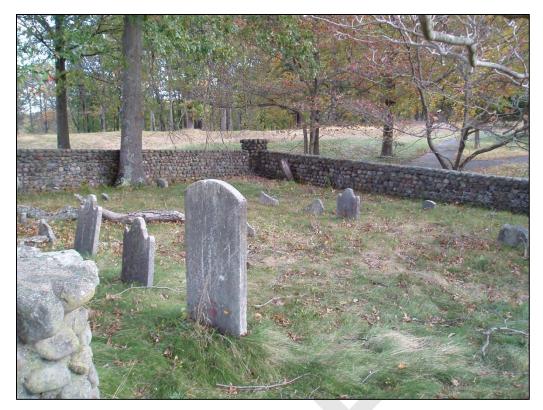
Photograph 19. Cemetery, interior looking NE (Field Photograph CemeteryInterior\_2019\_P1010028, 10/18/19).

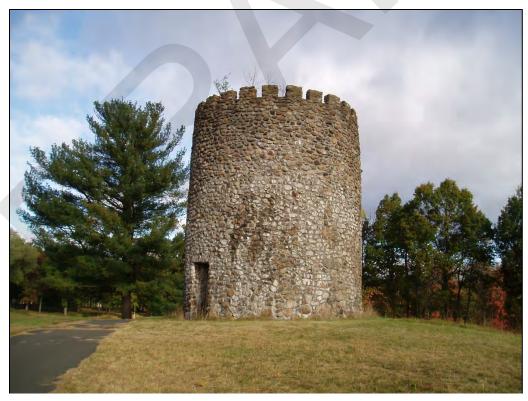
Photograph 20. Stone tower (T1), looking NW (Field Photograph TowerNW\_2019\_P1010017, 10/18/19).

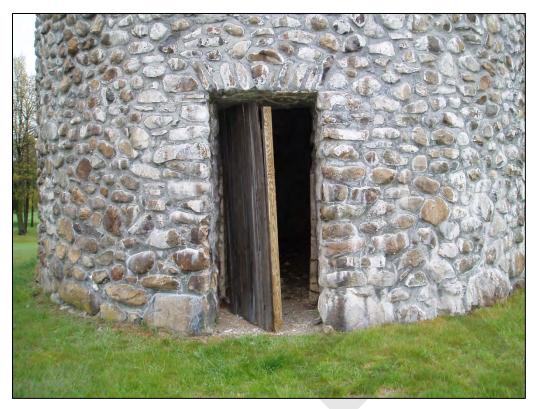
Photograph 21. Stone tower (T1), door detail (Field Photograph TowerNW\_Door\_2016\_P1010018, 5/4/16).

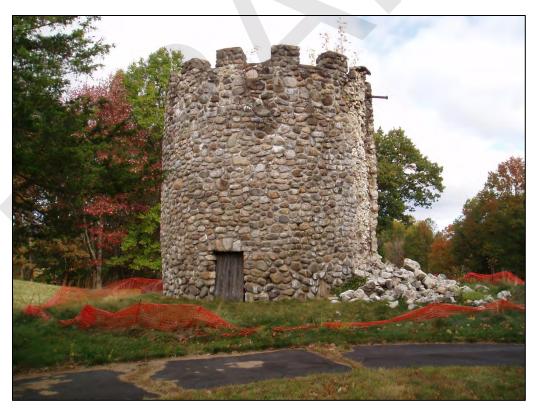
Photograph 22. Stone tower (T2), looking N (Field Photograph TowerSE\_2019\_P1010039, 10/18/19).

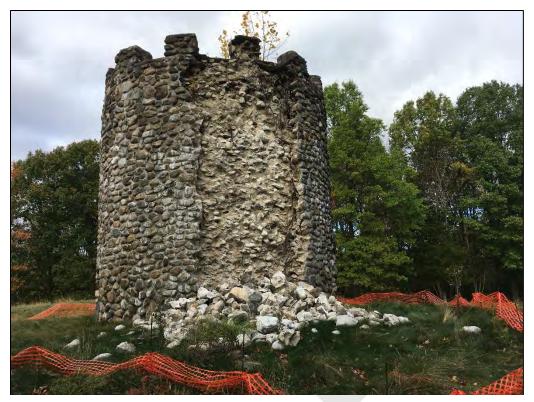
Photograph 23. Stone tower (T2), looking at the collapsed east side of the structure (Field Photograph TowerSE\_2019\_IMG\_0633, 10/18/19).

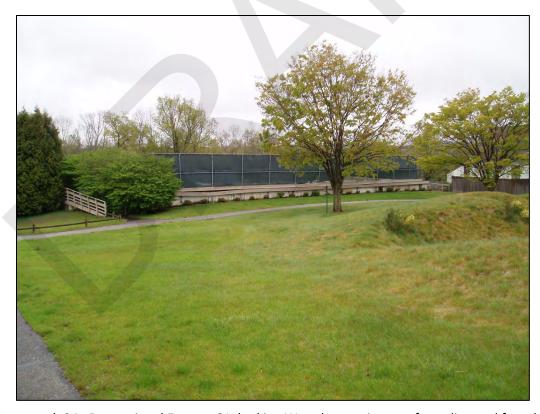
Photograph 24. Recreational Feature S1, looking W at the tennis court fence line and foundation (Field Photograph PoolTennis\_2016\_P1010032, 5/4/16).

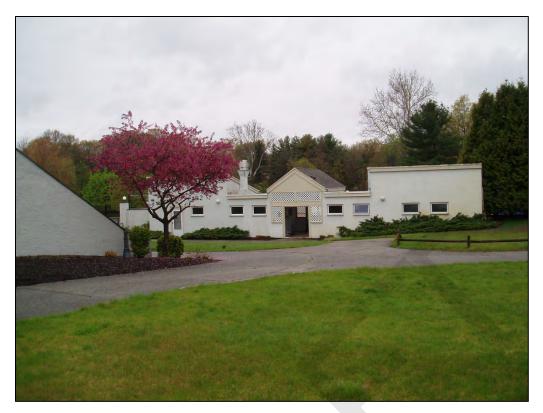
Photograph 25. Recreational Feature S2, looking W at the east façade of the pool house (Field Photograph PoolTennis\_2016\_P1010022, 5/4/16).

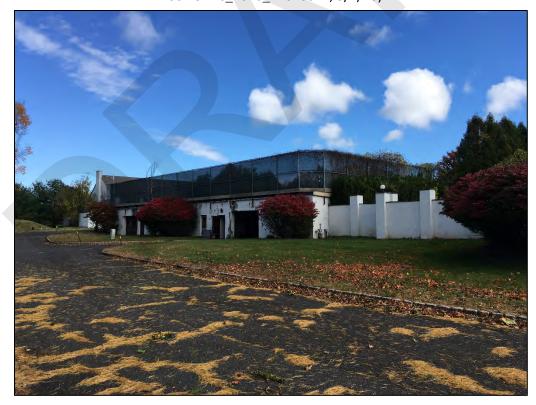
Photograph 26. Recreational Features S1 and S2, looking NE at the west (back) walls of the tennis court (left) and the pool house (right) (Field Photograph PoolTennis\_2019\_IMG\_0678, 10/18/19).

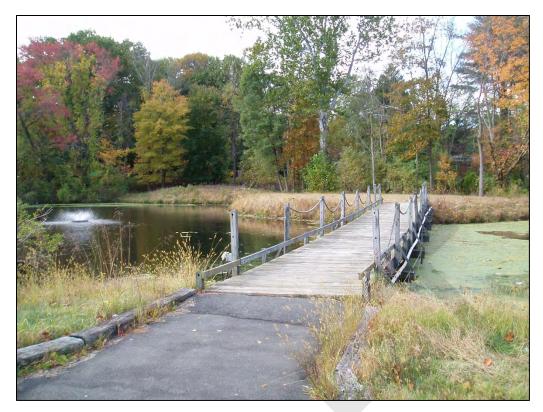
Photograph 27. Wood causeway C1, looking W (Field Photograph Causeway01DamPond\_2019\_P1010063, 10/18/19).

1991 Building # on Figure 4	1991 Building Name	2019 Figure 2 Status and/or Designation	2019 Proposed Action
No #	Wood causeway	C1, C2, and C3	To be demolished for proposed project.
Not present	Golf Course restroom	2019-7	To be demolished for proposed project
Not present	Pond water pump house	2019-8	Outside of impact line for proposed project.

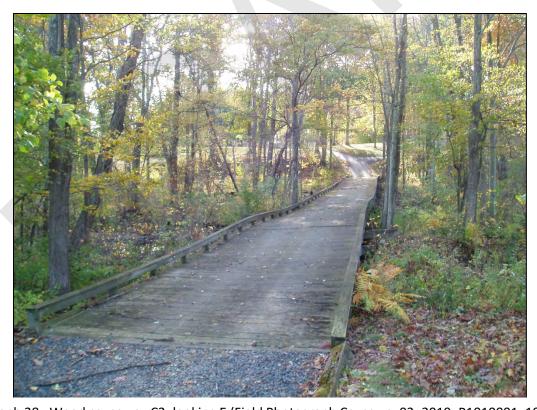
Photograph 28. Wood causeway C2, looking E (Field Photograph Causeway O2\_2019\_P1010001, 10/18/19).

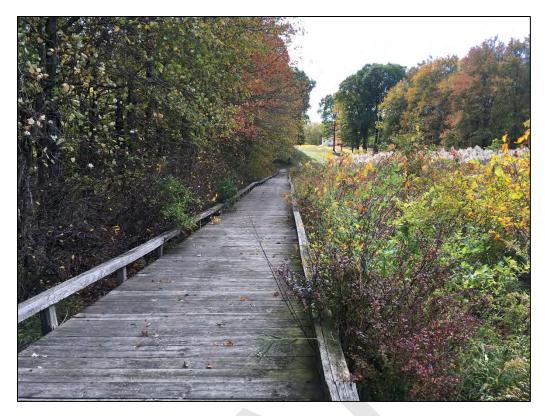
Photograph 29. Wood causeway C3, looking S with Building 6 (1991) in the background (Field Photograph Causeway03\_2019\_IMG\_0688, 10/18/19).

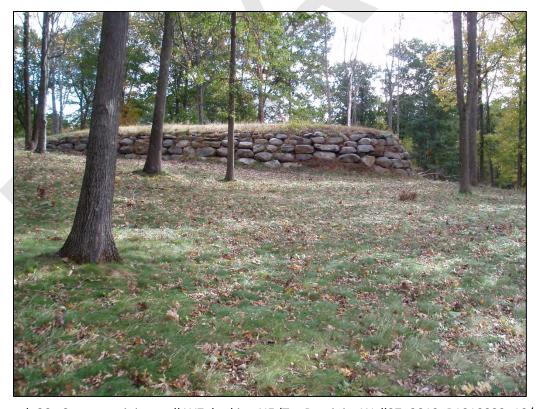
Photograph 30. Stone retaining wall W7, looking NE (TeeRetainingWall07\_2019\_P1010032, 10/18/19).

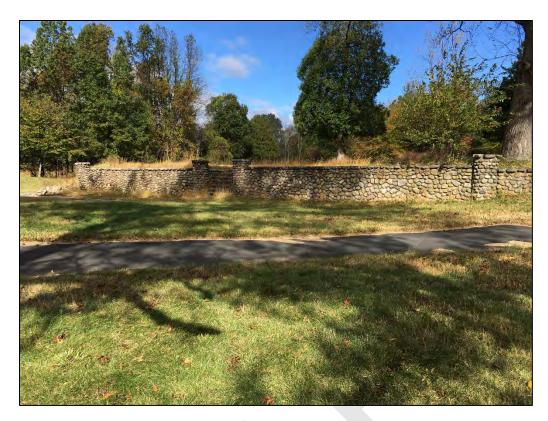
Photograph 31. Stone retaining wall W10, looking NW at what appears to be the entry stairs (RetainingWallW10\_2019\_IMG\_0686, 10/18/19).

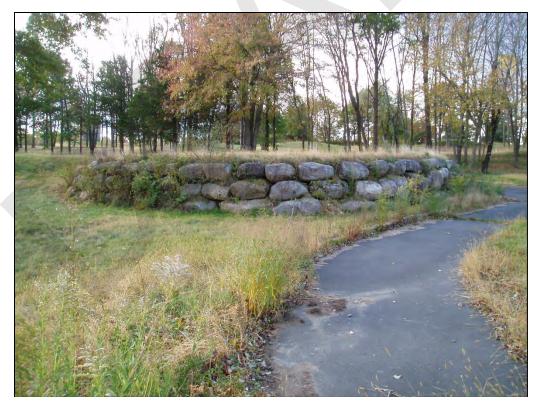
Photograph 32. Stone retaining wall W11, looking SE (Field Photograph TeeRetainingWallW11\_2019\_P1010010, 10/18/19).

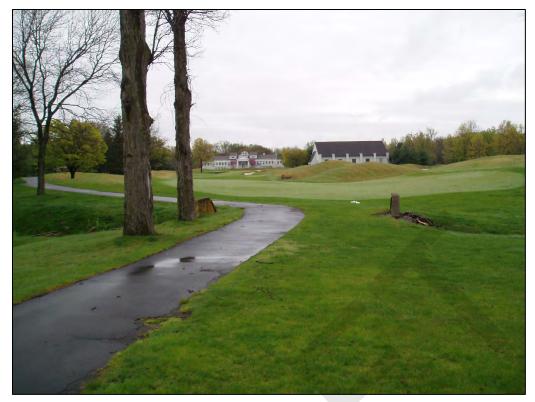
Photograph 33. Golf Course, looking S at Bldg. 12 (1991) to right and Bldg. 11 (1991) to left (Field Photograph GolfCourse\_2016\_P1010022, 05/04/16).

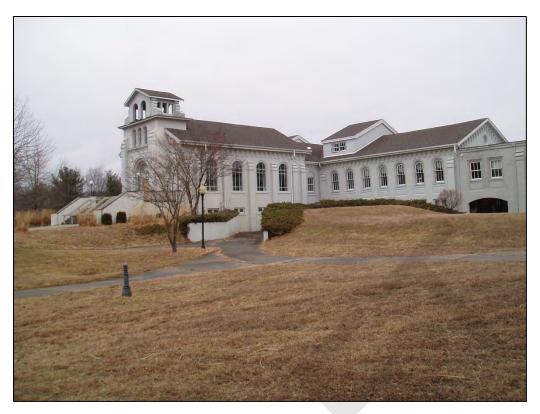
Photograph 1. Clubhouse Exterior, looking NW at the SE facades (Field Photograph P101001, 2/10/2020).

Photographs 1 through 10 show the existing conditions of the building's exterior. Of particular note is Photograph 1. The paved walkway/cart path between the landscaping and the east facing façade provides access to the entranceway to the Ladies Locker Room alcove. This entrance is shown in Photograph 48.

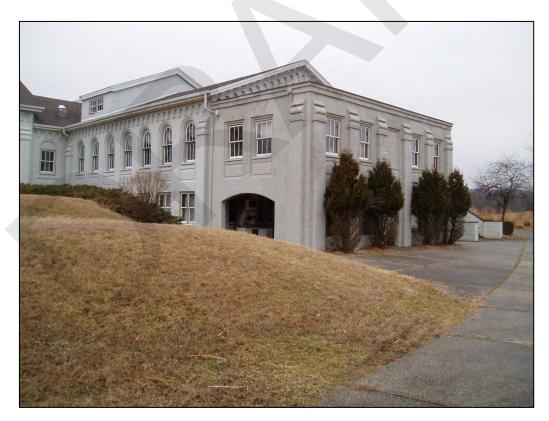
Photograph 2. Club Exterior, looking NW at the S and E facades. The lower level arch to picture center is the south side of the breezeway (Field Photograph P1010003, 2/10/2020).

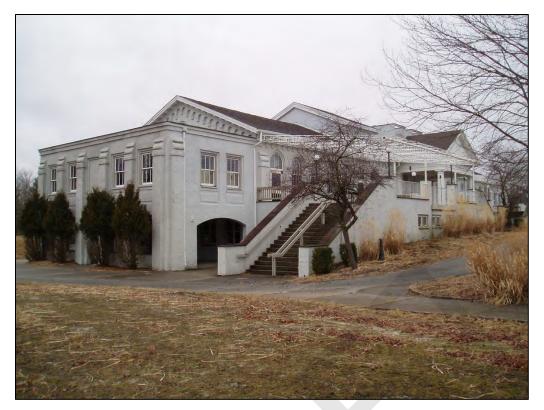
Photograph 3. Club Exterior, looking SW at the E and N facades. The lower level arch to picture center, behind the staircase, is the north side of the breezeway (Field Photograph P1010004, 2/10/2020).

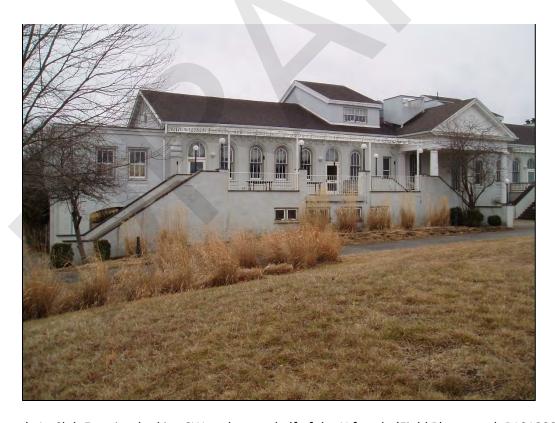
Photograph 4. Club Exterior, looking SW at the east half of the N façade (Field Photograph P1010005, 2/10/2020).

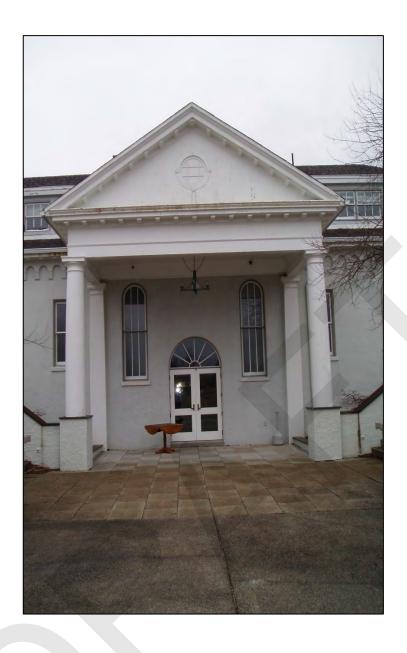
Photograph 5. Club Exterior, looking S at the ground floor entrance to the building showing the flanking staircases to Floor 2-Main (Field Photograph P1010008-Vertical, 2/10/2020).

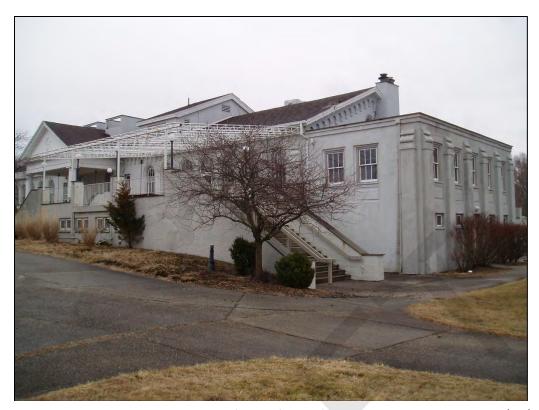
Photograph 6. Club Exterior, the west side of the N facade (Field Photograph P1010010, 2/10/2020).

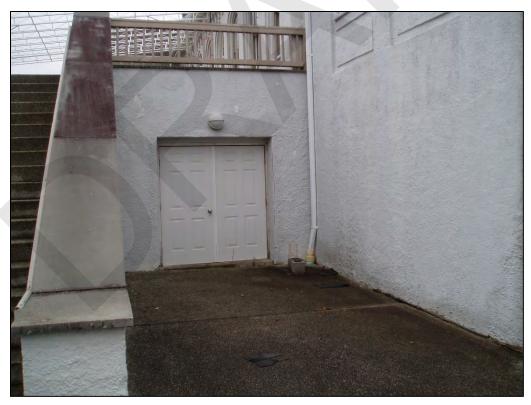
Photograph 7. Club Exterior, the service entrance to the Floor 1-Ground level (Field Photograph P1010011, 2/10/2020).

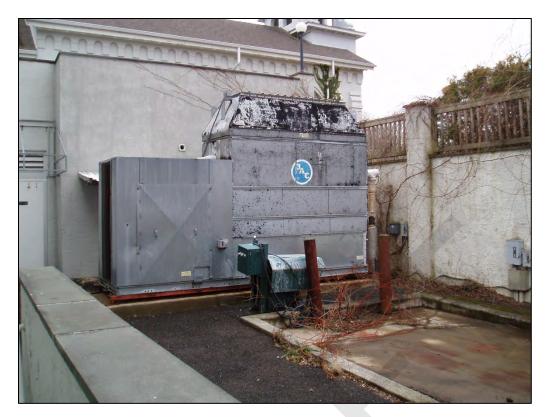
Photograph 8. Club Exterior, Utility yard on the west side of the clubhouse outside Floor 1-Ground (Field Photograph P1010012, 2/10/2020).

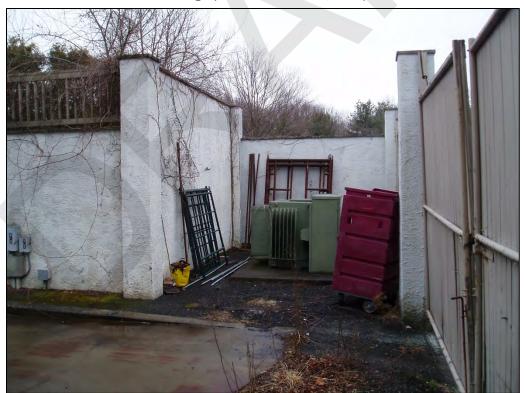
Photograph 9. Club Exterior, another section of the utility yard shown in Photographs 8 and 10 (Field Photograph P1010013, 2/10/2020).

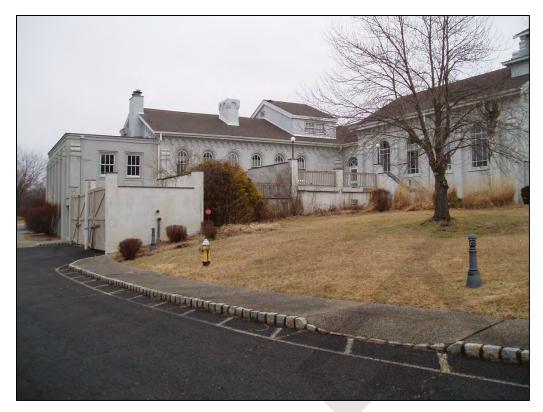
Photograph 10. Club Exterior, south and west facades. The utility yard is behind the swing doors to picture left (Field Photograph P1010015, 2/10/2020).

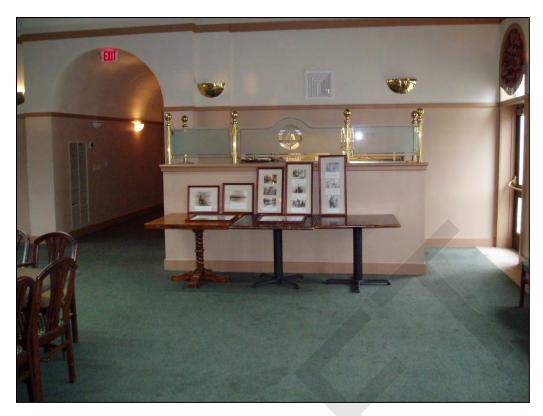
Photograph 15. Floor 2-Main, Room 2, looking SW at the room interior showing the arched entry way and the south side service station, to left of entry arch (Field Photograph P1010025, 2/10/2020).

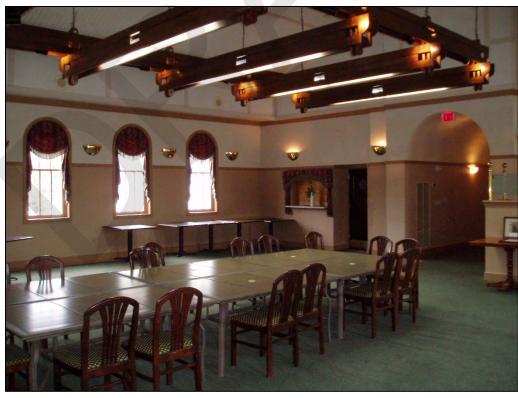
Photograph 16. Floor 2-Main, Room 2 looking east at the entry door from Room 2 to Room 3 (Field Photograph P1010027, 2/10/2020).

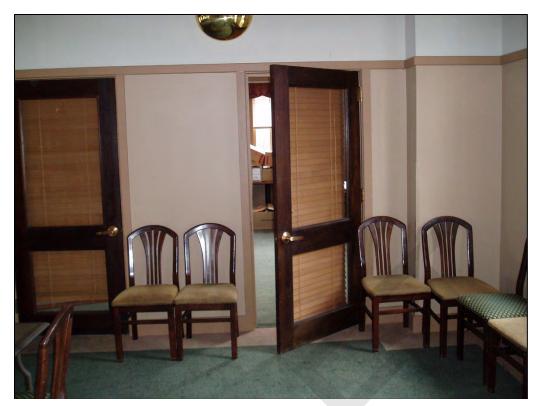
Photograph 17. Floor 2-Main, Room 3, looking NE at the room interior from the entry door in Photograph 16 (Field Photograph P1010025, 2/10/2020).

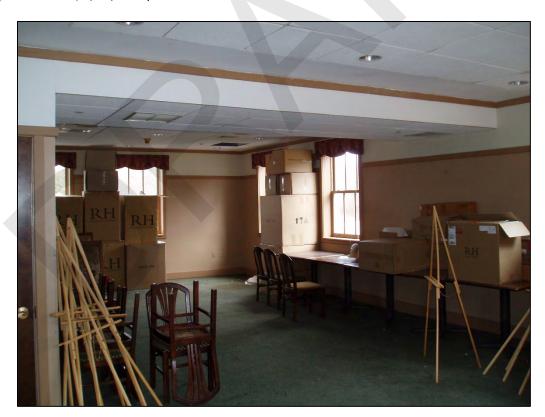
Photograph 18. Floor 2-Main, Room 4 pantry. This pantry services Rooms 2 and 5 (Field Photograph P1010030, 2/10/2020).

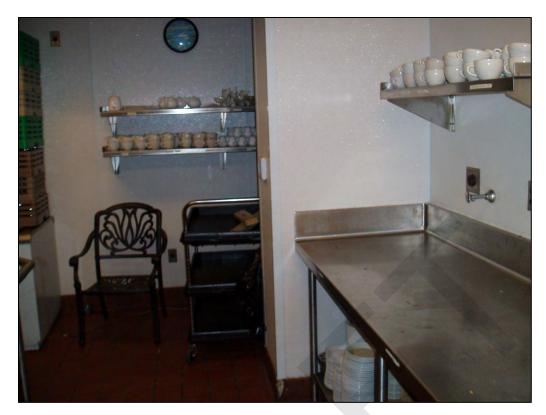
Photograph 19. Floor 2-Main, Room 5, full kitchen that backs to Room 2 (Field Photograph P1010035, 2/10/2020).

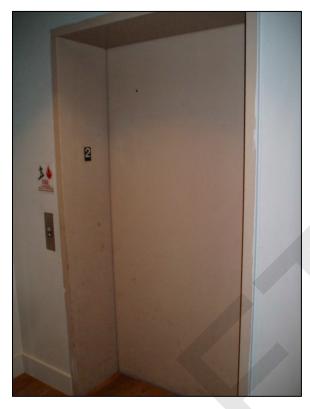
Photograph 23. Floor 2-Main, looking at the elevator which is marked "2" (Field Photograph P1010040-Vertical. 2/10/2020).

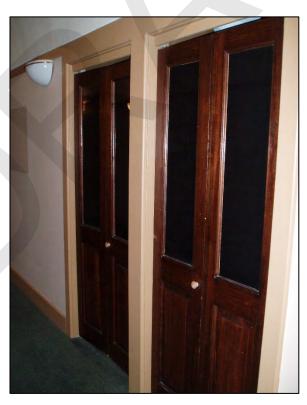
Photograph 24. Floor 2-Main, looking at the twin closets adjacent to the restrooms. The doors fold out and the 'closets' may have served as telephone booths at some point (Field Photograph P1010054, 2/10/2020).

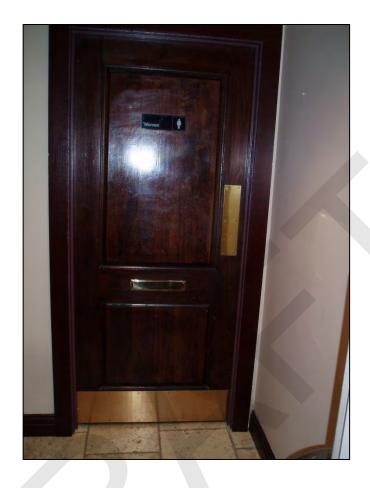
Photograph 25. Floor 2-Main, Room 7, Ladies Room entry door from the entrance alcove (Field Photograph P1010044-Vertical, 2/10/2020).

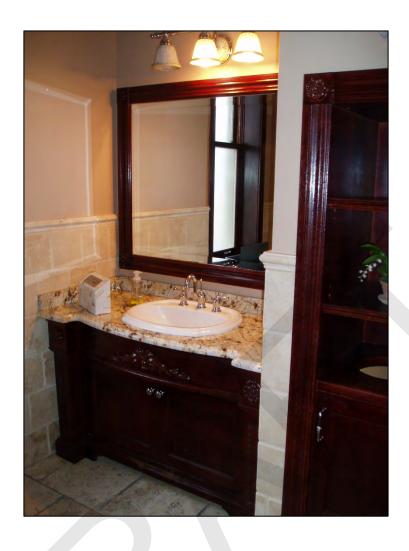
Photograph 26. Floor 2-Main, Room 7, Ladies Room sink/mirror (Field Photograph P1010046-Vertical, 2/10/2020).

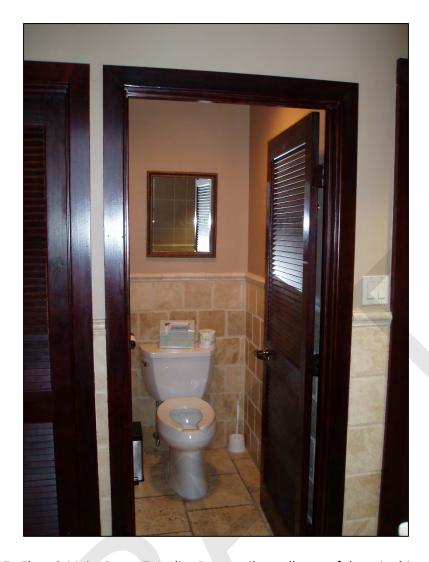
Photograph 27. Floor 2-Main, Room 7, Ladies Room toilet stall, one of three in this restroom (Field Photograph P1010047-Vertical, 2/10/2020).

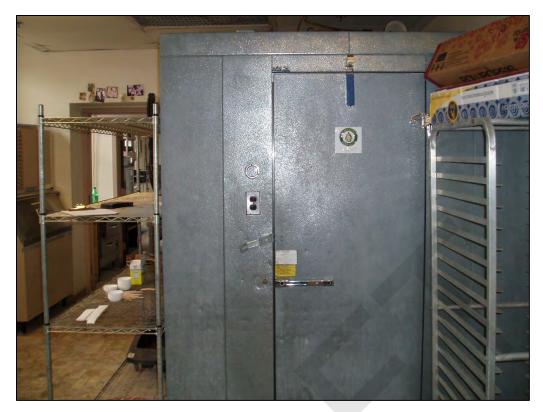
Photograph 28. Floor 2-Main, Room 6 showing one of the two walk-in storage refrigerators in this kitchen (Field Photograph P1010042, 2/10/2020).

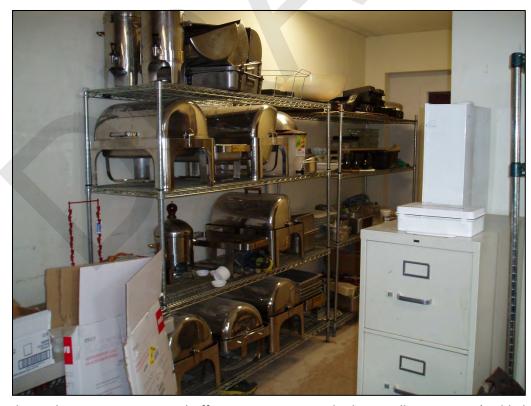
Photograph 29. Floor 2-Main, Room 6, buffet warming trays and other small equipment (Field Photograph P1010041, 2/10/2020).

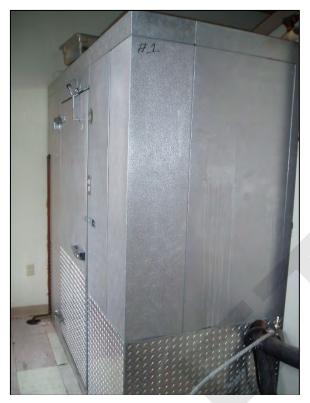
Photograph 30. Floor 2-Main, Room 6, walk-in storage refrigerator marked "#1" (Field Photograph P1010043-Vertical, 2/10/2020).

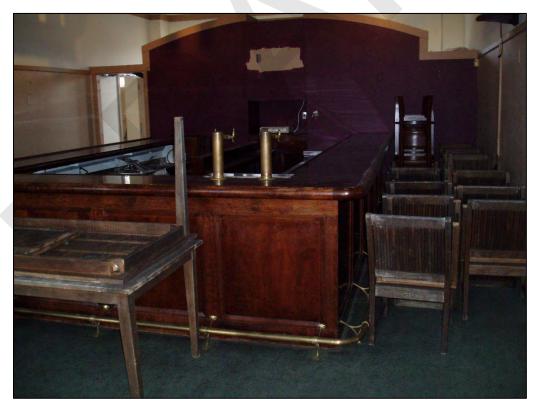
$Photograph\ 31.\ Floor\ 2-Main,\ Room\ 8,\ bar\ detail\ showing\ foot\ rail\ (Field\ Photograph\ P1010050,\ 2/10/2020).$

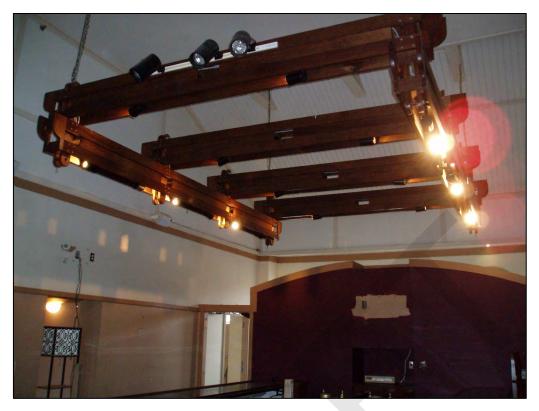
Photograph 32. Floor 2-Main, Room 8 bar light fixture suspended above bar (Field Photograph P1010051, 2/10/2020).

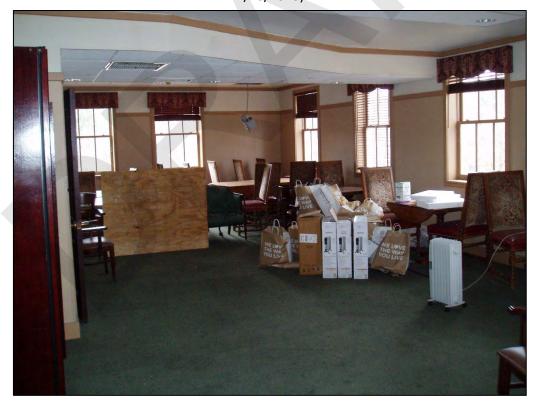
Photograph 33. Floor 2-Main, Room 9 looking SW at stored event tables, chairs, and other materials (Field Photograph P1010052, 2/10/2020).

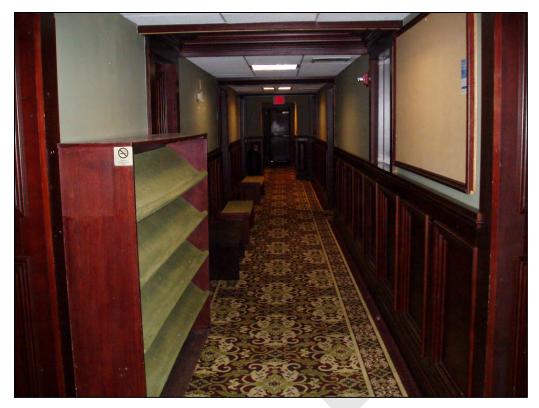
Photograph 34. Floor 1-Ground, Men's Locker Room, main hall looking toward the outside exit (Field Photograph P1010057, 2/10/2020).

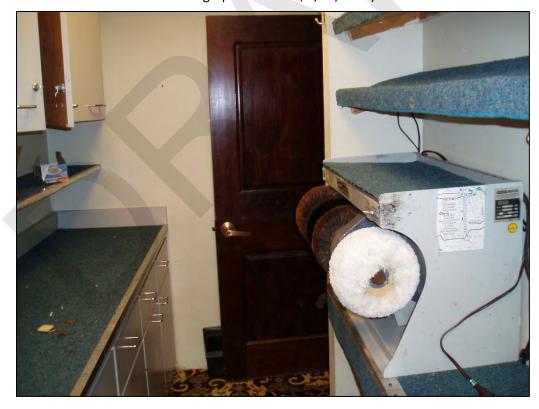
Photograph 35. Floor 1-Ground, Men's Locker Room 10a, shoe cleaning room looking back toward the room's entry door (Field Photograph P1010059, 2/10/2020).

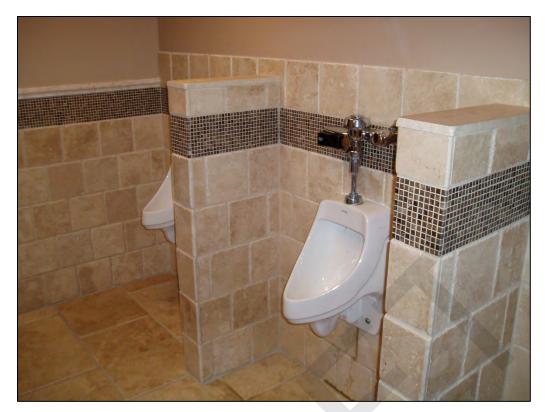
Photograph 36. Floor 1-Ground, Men's Locker Room 10b, toilet room urinals (Field Photograph P1010063, 2/10/2020).

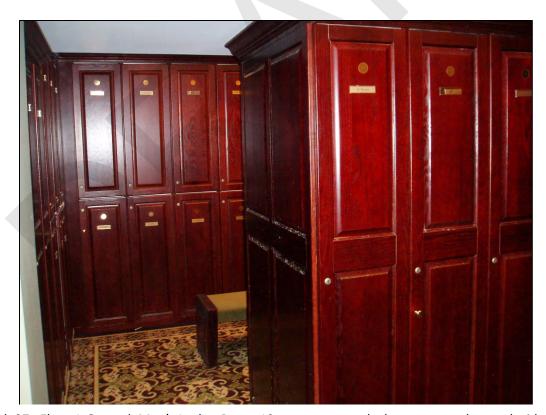
Photograph 37. Floor 1-Ground, Men's Locker Room 10e, easternmost locker room on the north side of the main hallway (Field Photograph P1010060, 2/10/2020).

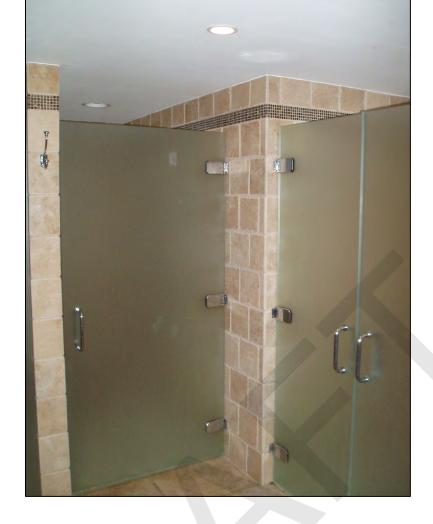
Photograph 38. Men's Locker Room, Room 10c, stall on right is wheelchair accessible (Field Photograph P1010065-vertical, 2/10/2020).

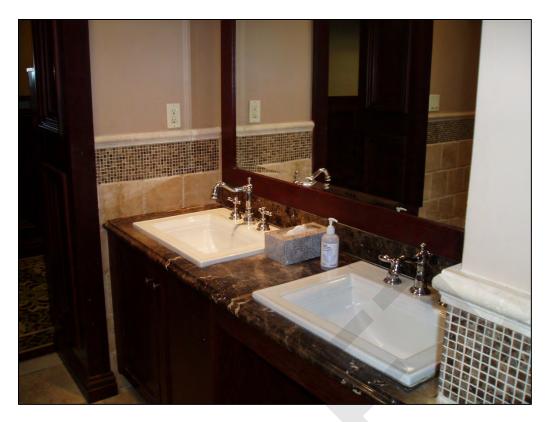
Photograph 39. Floor 1-Ground, Men's Locker Room 10b, toilet room sinks (Field Photograph P1010064, 2/10/2020).

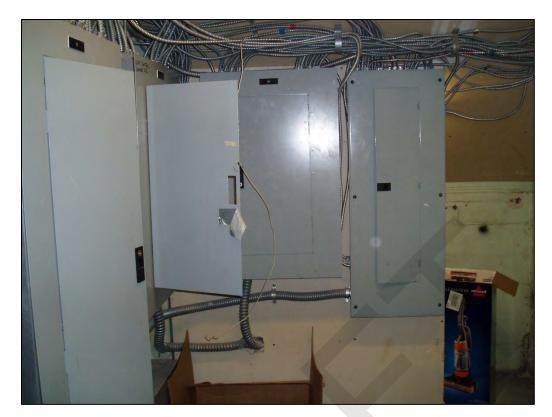
Photograph 41. Floor 1-Ground, utility room (Field Photograph P1010091, 2/10/2020).

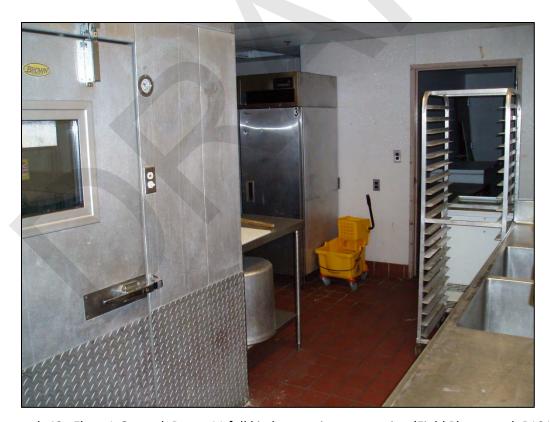
Photograph 42. Floor 1-Ground, Room 11 full kitchen equipment section (Field Photograph P1010069, 2/10/2020).

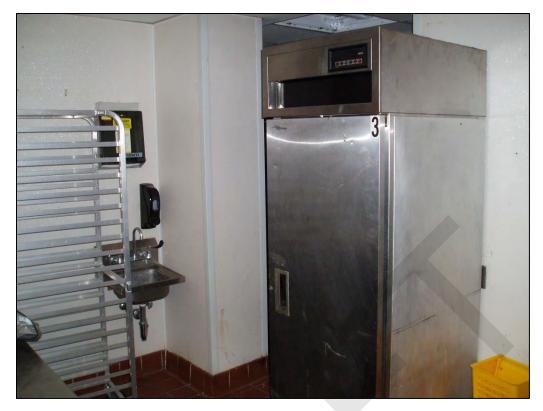
Photograph 43. Floor 1-Ground, Room 11 equipment area (Field Photograph P1010071, 2/10/2020).

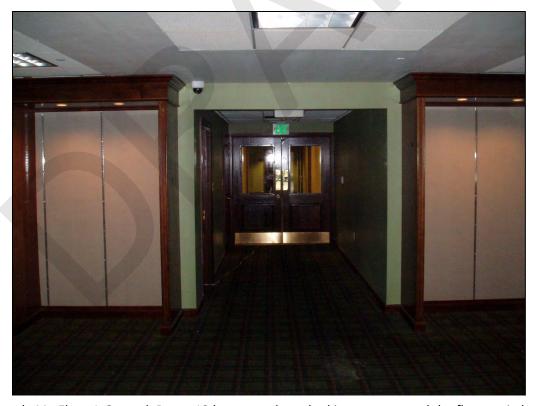
Photograph 44. Floor 1-Ground, Room 12 bar entry doors looking west toward the floor main hall (Field Photograph P1010074, 2/10/2020).

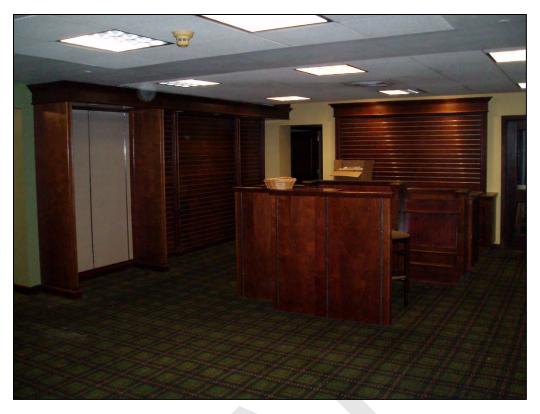
Photograph 45. Floor 1-Ground, Room 12 bar looking NW toward the Room 13 doorway (Field Photograph P1010075, 2/10/2020).
