#### **Town of Ramapo**

# Comprehensive Plan Amendment for the Northeast Ramapo Development Plan and Comprehensive Plan Update of Town-wide Existing Conditions and

# DRAFT GENERIC ENVIRONMENTAL IMPACT STATEMENT (DGEIS) APPENDICES – VOLUME IV OF IV:

# APPENDIX L: MINISCEONGO PARK SITE PLAN INFORMATION

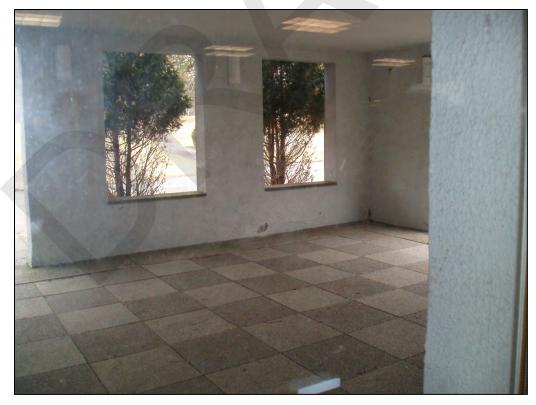
Photograph 46. Floor 1-Ground, looking east from Room 12 toward the Floor 1-Ground breezeway (Field Photograph P1010079).

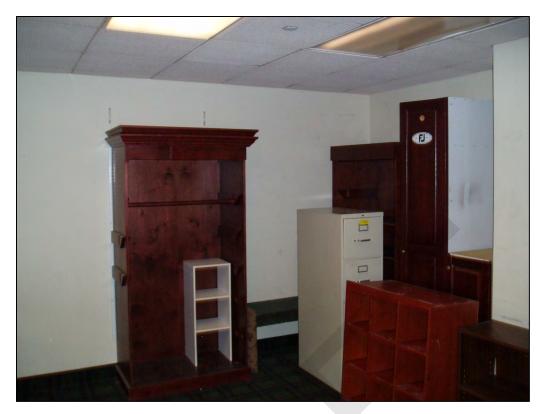
Photograph 47. Floor 1-Ground, Room 13 equipment storage (Field Photograph P1010078, 2/10/2020).

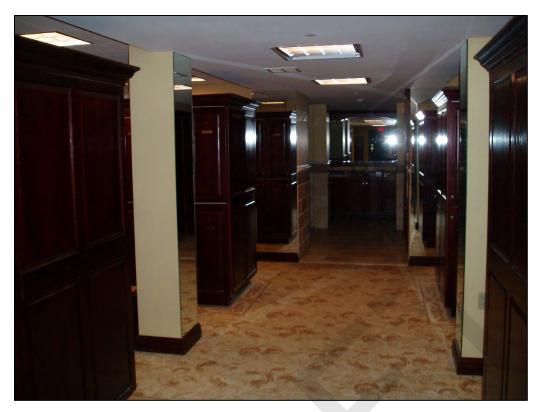
Photograph 49. Floor 1-Ground, Room 17, Ladies Locker Room, showing main hall and locker clusters (Field Photograph P1010084, 2/10/2020).

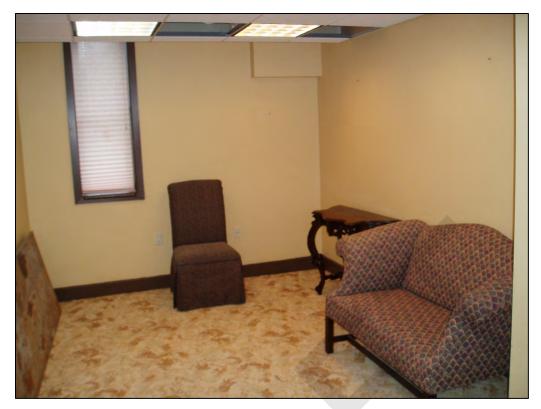
Photograph 51. Floor 1-Ground, Ladies Locker Room 17b, lounge (Field Photograph P1010083, 2/10/2020).

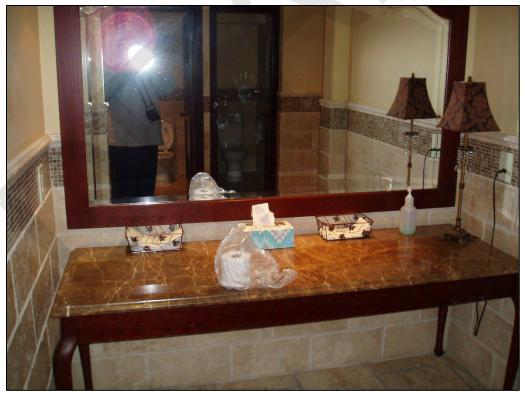
Photograph 52. Floor 1-Ground, Ladies Locker Room 17, makeup table (Field Photograph P1010085, 2/10/2020).

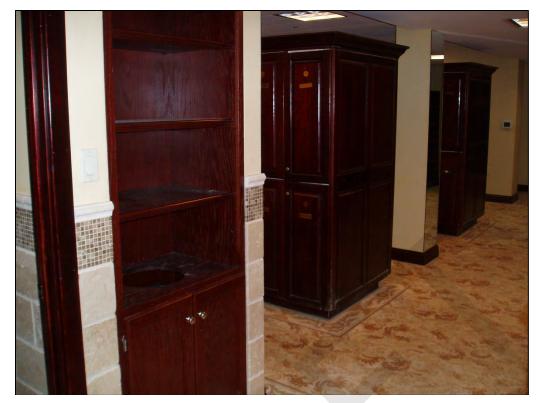
Photograph 53. Floor 1-Ground, Ladies Locker Room 17, another view of the locker clusters (Field Photograph P1010089, 2/10/2020).

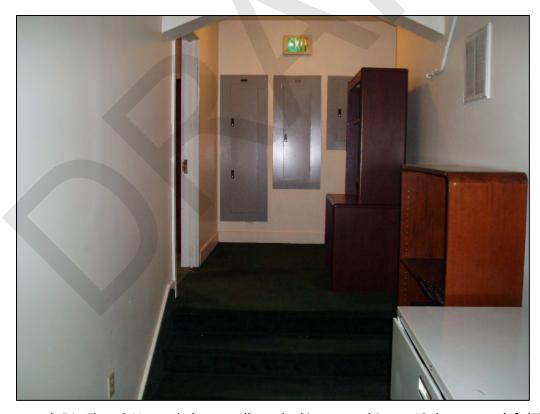
Photograph 54. Floor 3-Upper, balcony walkway looking toward Room 19 doorway to left (Field Photograph P1010096, 2/10/2020).

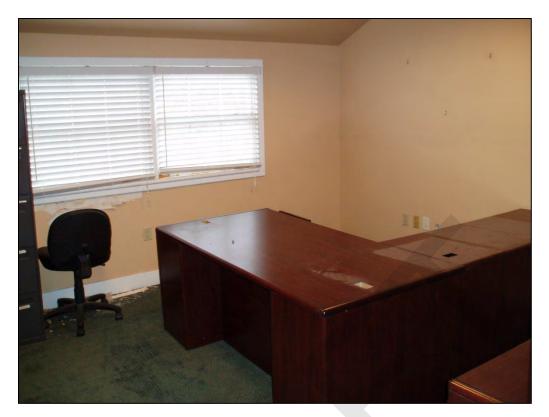
Photograph 55. Floor 3-Upper, Room 19, small office adjacent to choir loft on the west side of the floor (Field Photograph P1010097, 2/10/2020).

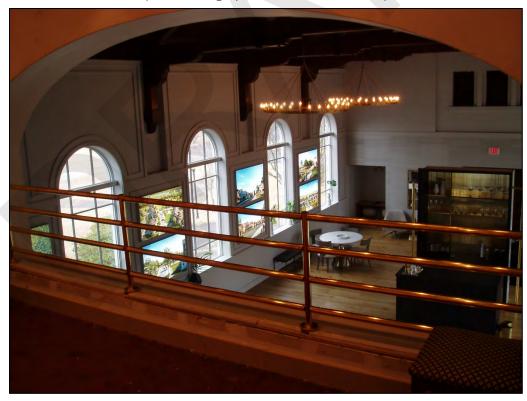
Photograph 56. Floor 3-Upper, choir loft showing rail detail and another view of Room 1 below (Field Photograph P1010093, 2/10/2020).

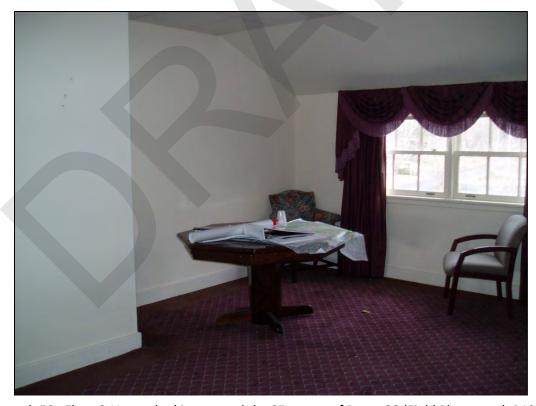
Photograph 58. Floor 3-Upper, looking toward the SE corner of Room 20 (Field Photograph P1010101, 2/10/2020).

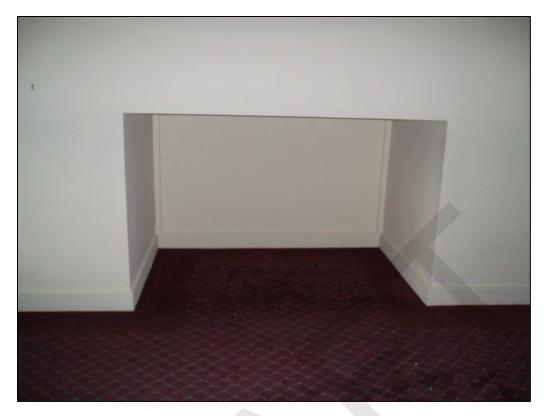
Photograph 59. Floor 3-Upper, Room 20 looking east at the alcove in the east wall (Field Photograph P1010100, 2/10/2020).

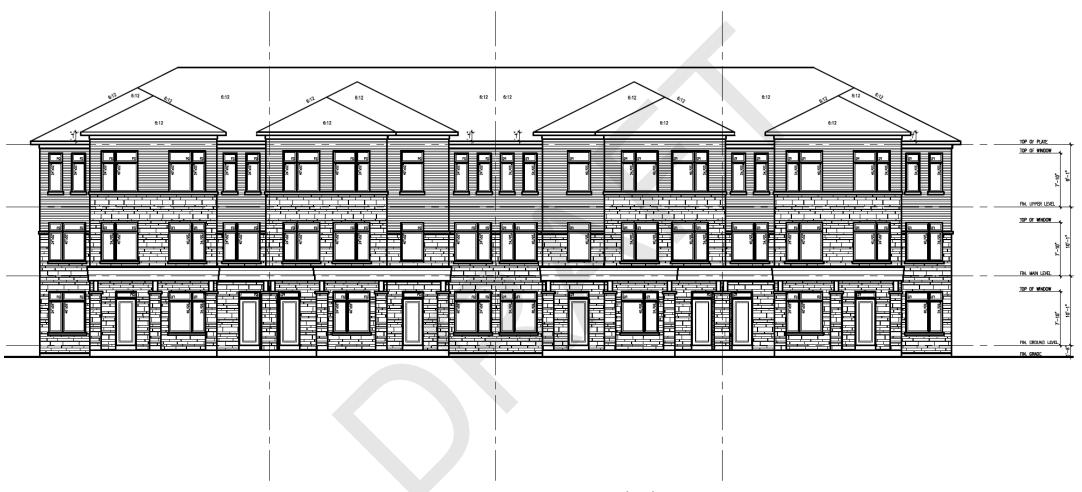
FRONT ELEVATION 'A'

## STACKED DECK MANOR TOWN HOME ELEVATIONS & FLOORPLANS

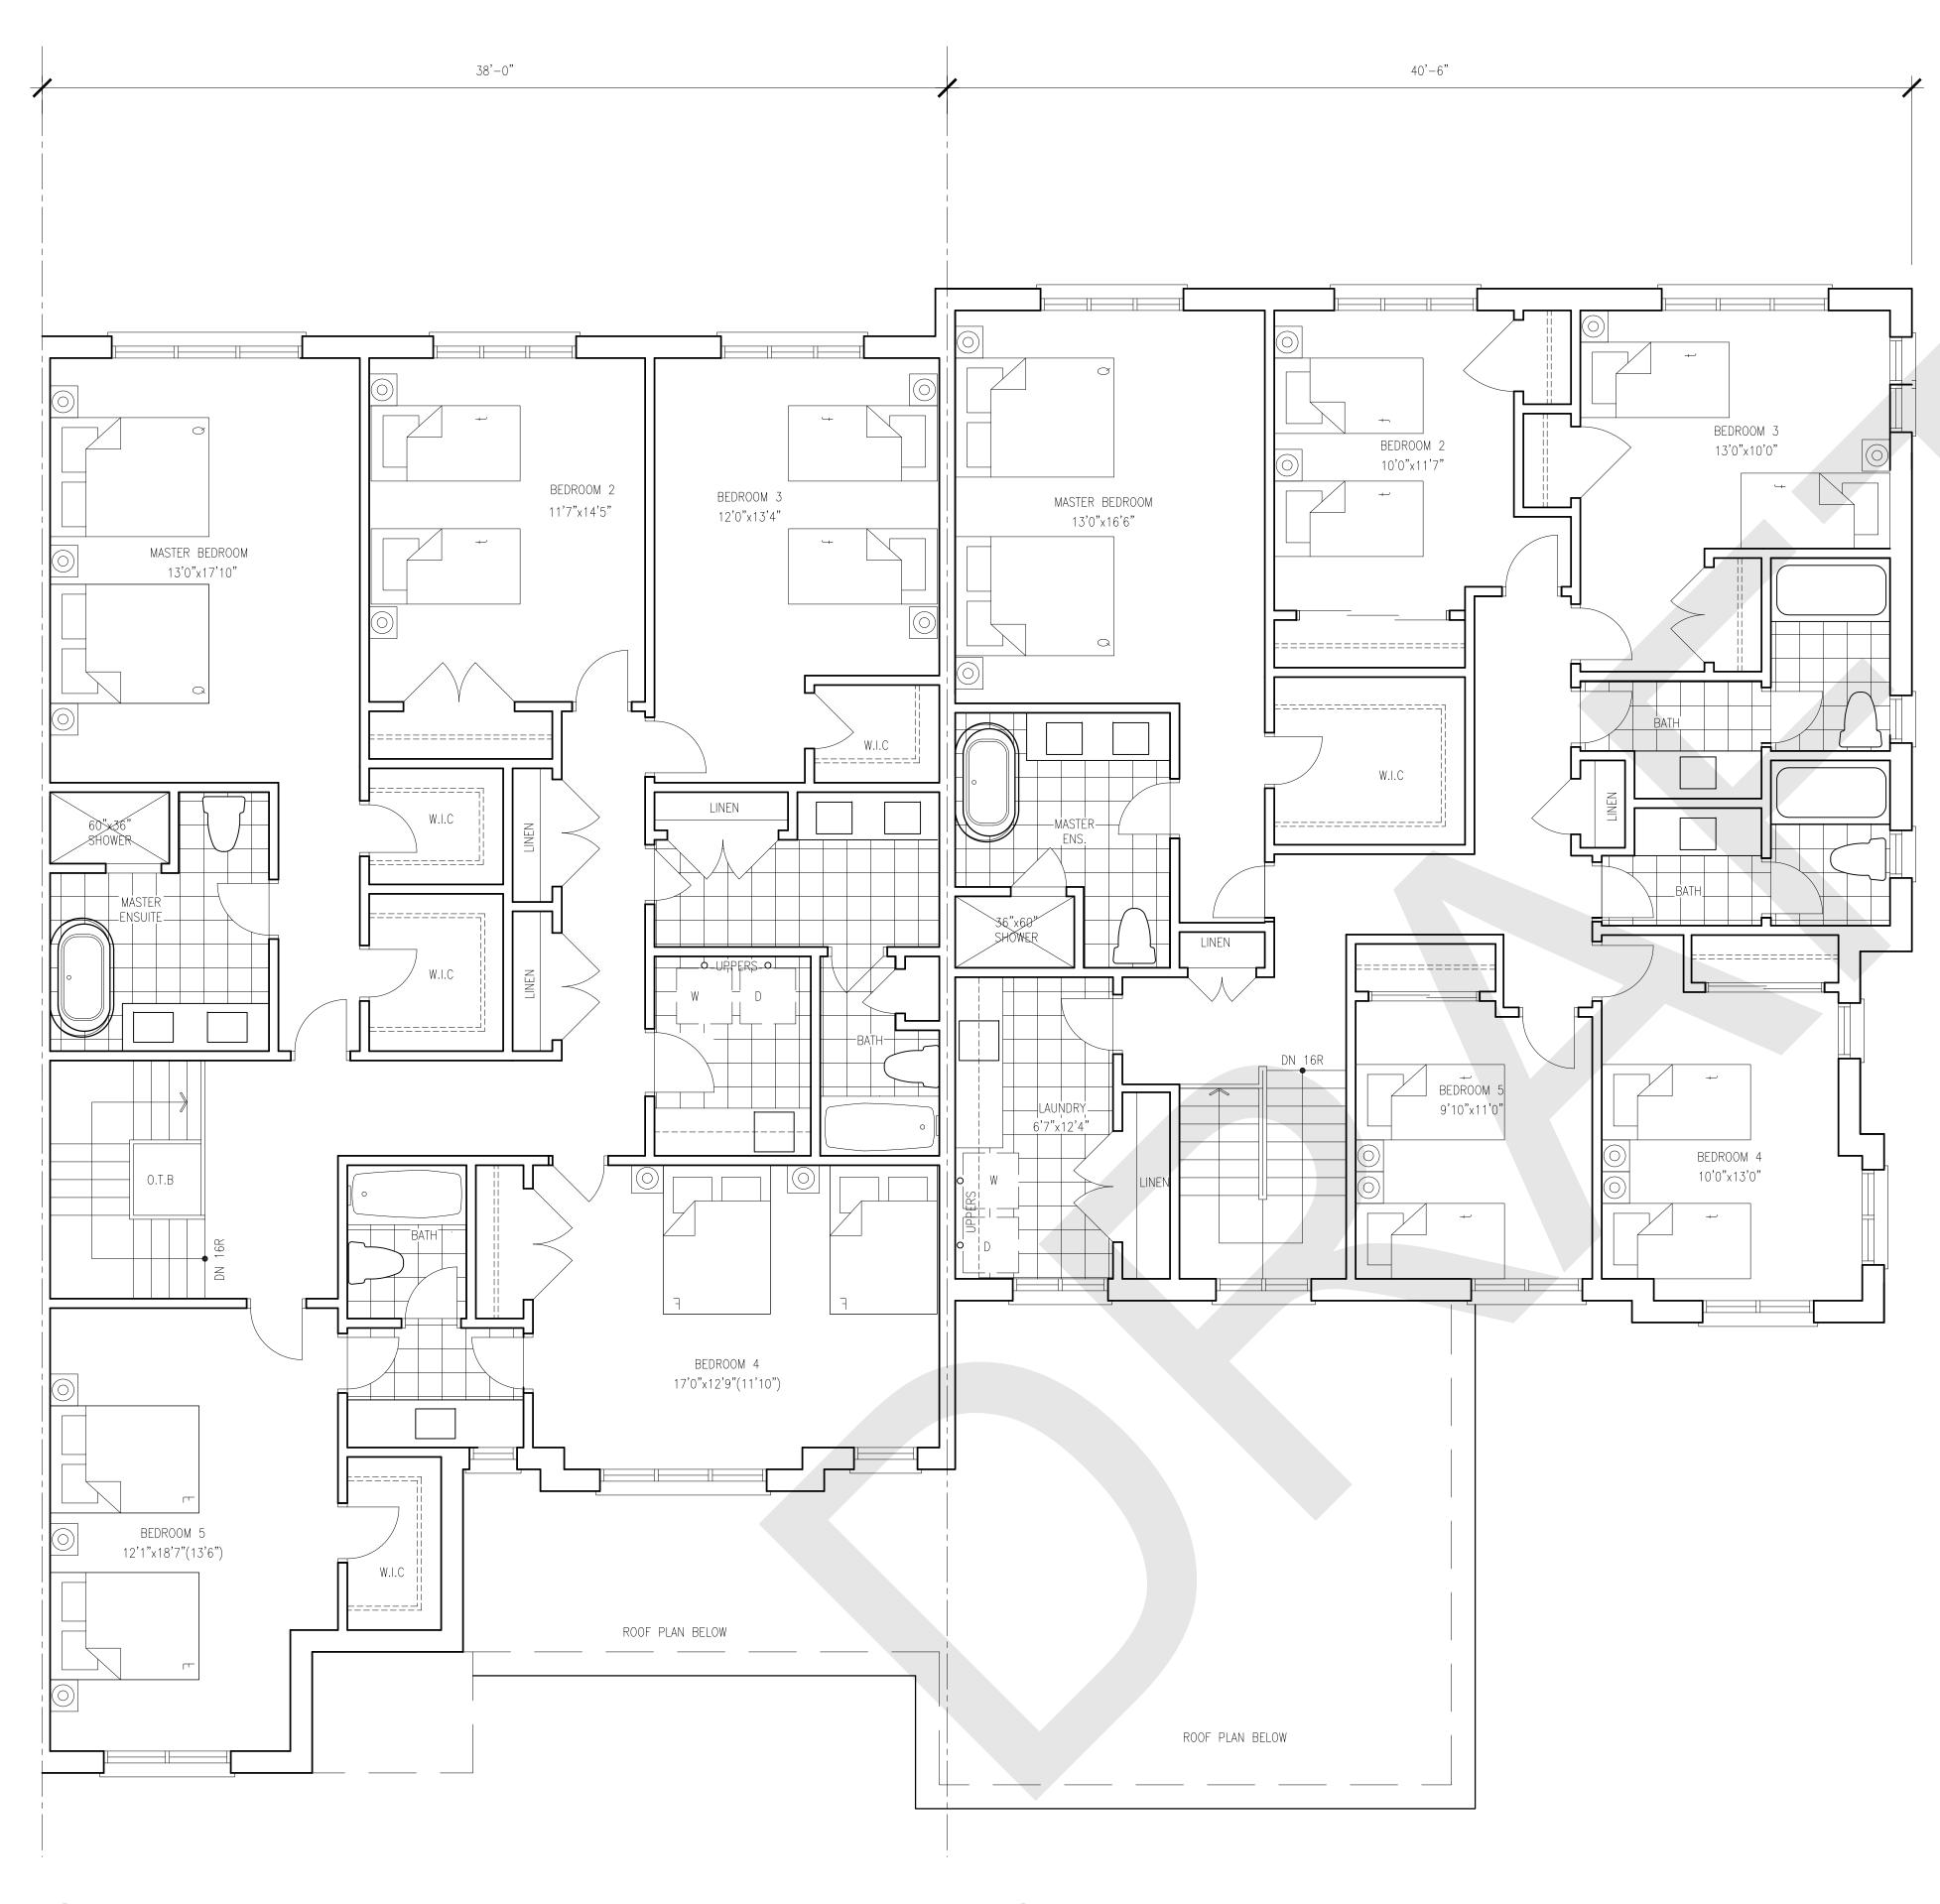
1 ST-2 SECOND FLOOR PLAN
A-102 SCALE: 1/4" = 1'-0"

2 ST-1 SECOND FLOOR PLAN
SCALE: 1/4" = 1'-0"

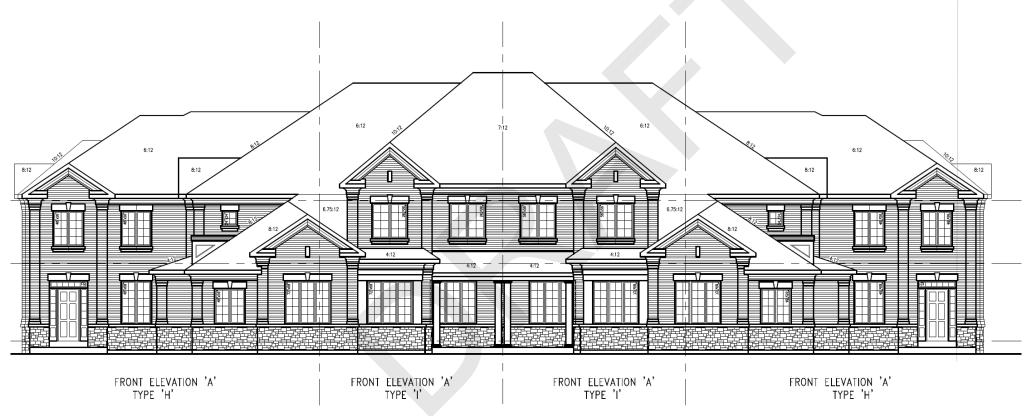
FRONT ELEVATION 'A'

## QUAD TOWN HOME - FRONT ENTRY TYPE ELEVATION

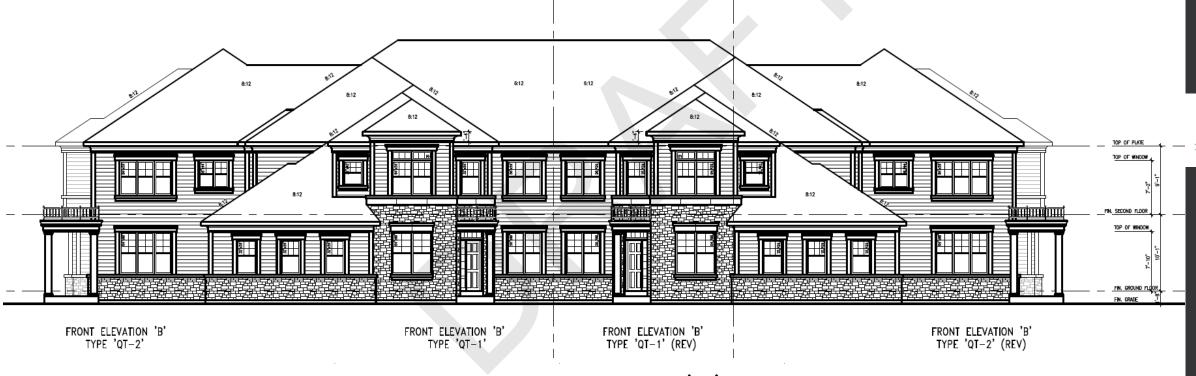
FRONT ELEVATION 'B'

# QUAD TOWN HOME - SIDE ENTRY TYPE ELEVATION

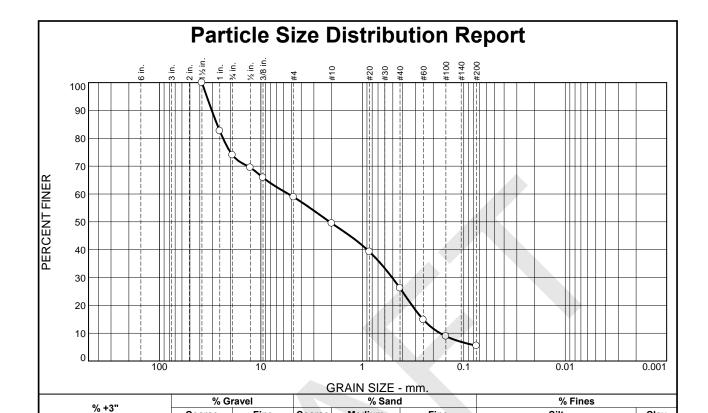
Figure S-3

TEST RESULTS (D6913)			
Opening	Percent	Spec.*	Pass?
Size	Finer	(Percent)	(X=Fail)
1.5"	100.0		
1"	82.6		
0.75"	74.0		
0.5"	69.5		
0.375"	65.9		
#4	58.9		
#10	49.5		
#20	39.2		
#40	26.2		
#60	14.9		
#100	8.9		
#200	5.5		
* (	cification provid	- 4\

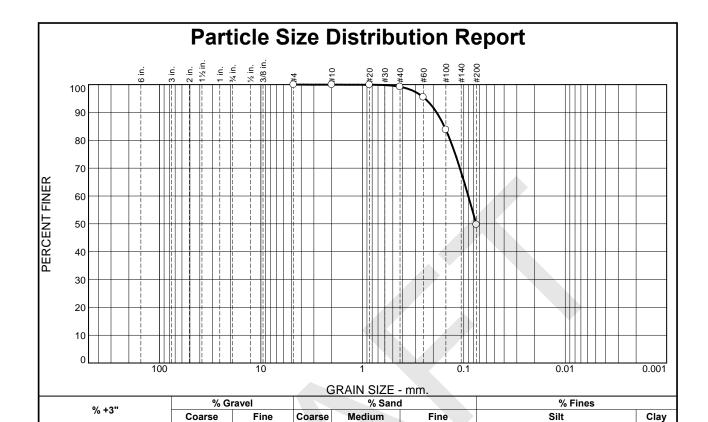
Figure S-4

Opening	Percent	Spec.*	Pass?
Size	Finer	(Percent)	(X=Fail)
#4	100.0		
#10	100.0		
#20	99.9		
#40	99.2		
#60	95.5		
#100	83.8		
#200	49.7
